# Evaluation of surface characteristics of new rotary nickel-titanium instruments – SEM-EDS analysis

Milica Jovanović Medojević<sup>1</sup>, Alena Zdravković<sup>2</sup>, Mina Medojević<sup>1</sup>, Đorđe Stratimirović<sup>1</sup>

<sup>1</sup>University of Belgrade, School of Dental Medicine, Belgrade, Serbia;

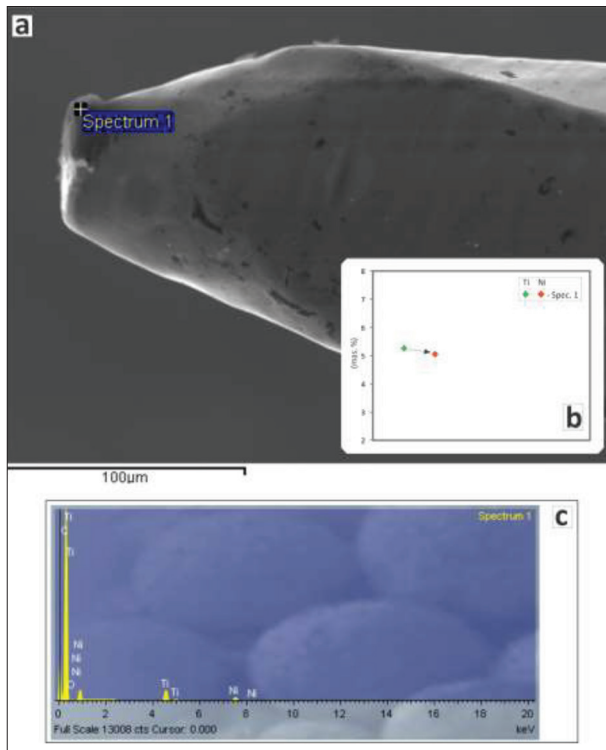
SEM-EDS analysis in point 1 (spectrum 1, Figure 1, Table 2) shows that dominant element in the examined sample was carbon (88.1 wt%) with low oxygen content (1.5 wt%), and impurity on this ProTaper Universal instrument is characterized as a debris of organic origin. Nickel and titanium contents (spectrum 1) reflect the composition of instrument.

**Figure 1.** SEM-EDS analysis of the new ProTaper (Sx) instrument a) SE image of the tip of ProTaper (Sx) instrument with the marked point where EDS analysis was performed, parts of its surface, b) nickel and titanium contents (wt%), c) spectrum of the analysed point  
**Slika 1.** SEM-EDS analiza površine novog ProTaper (Sx) instrumenta a) SE snimak vrha ProTaper (Sx) instrumenta sa označenom tačkom u kojoj je izvršena EDS analiza, dela njegove površine, b) sadržaji nikla i titanijuma (mas %), c) izgled spektra 1 za analizu u tački 1 (a)

**Table 2.** EDS analysis of the sample of ProTaper Universal (Sx) instrument in point 1 (Figure 1)

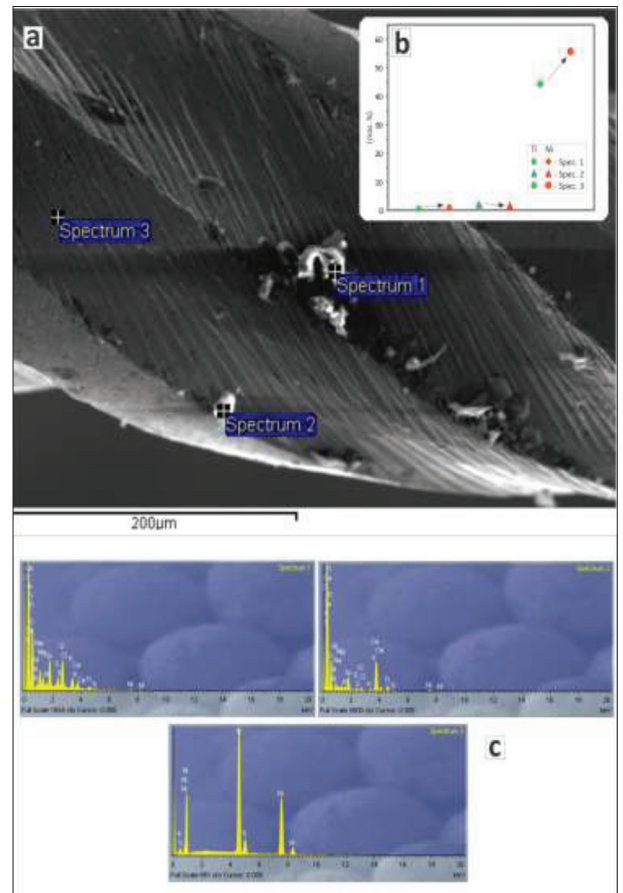
Based on SEM-EDS nalysis, the impurities on K3 instrument are characterized as a combination of debris of organic origin and contamination with metal strips. The quantity of nickel and titanium in analysis 1 (spectrum 1, Figure 2) and slightly more quantity of these two elements in analysis 2 (spectrum 2, Figure 2) represents the distribution of these elements in the structure of instruments, just like in the previous case.

**Tabela 3.** SEM-EDS analiza površine uzorka K3 (25-0.10) instrumenta u tačkama 1–3 (Slika 2)

**Figure 2.** SEM-EDS analysis of a new K3 (25-0.10) instrument a) SE image of K3 instrument surface with marked points where EDS analyzes were performed, b) nickel and titanium contents (wt%) at the analysed points (spectra 1–3), c) spectrums of the analysed points 1–3

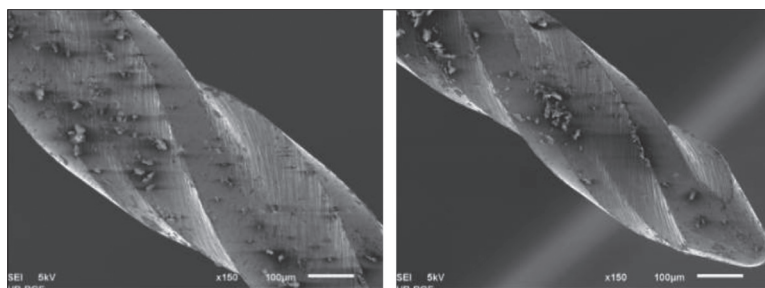
The presence of pitting and fritting (apical and middle third 100%), the presence of defects in the form of metal strips (apical third 83.33%, middle third 38.89%) and

corrosion on only one instrument (apical and middle third) (Figure 3) were noticed on the surface of working part of new K3 instruments. Debris was observed in apical third in 77.8% of instruments and in middle third in 44.44% of K3 instruments.

**Figure 3.** SE image of new K3 instruments: a) surface of middle third (25/0.10) with defects in the form of metal strips, pitting and fretting ( $\times 150$ ) b) surface of apical third (25/0.08) where defects in the form of metal strips, pitting and fretting can be observed ( $\times 150$ ).

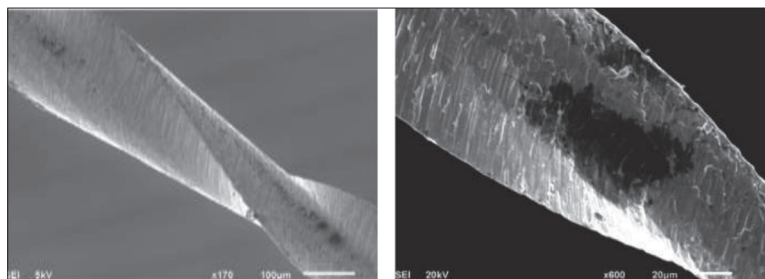
SEM analysis of Mtwo instruments indicated the presence of metal strips in apical (50%) and middle third (22.2%). The corrosion was observed only on one instrument (the thinnest one) (10 / 0.4) in its middle third (Figure 4).

**Figure 4.** SE image of new Mtwo instrument: a) surface of middle third (10/0.4) with the presence of corrosion ( $\times 170$ ); b) detail from the previous image at higher magnification ( $\times 600$ )

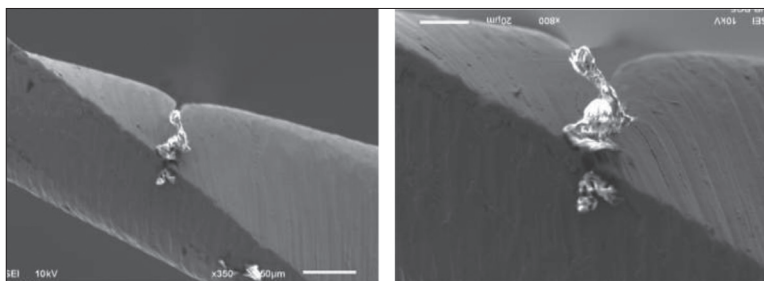
Blunt cutting edge of Mtwo instruments was observed on apical surface of one instrument (25 / 0.6) and defect in the form of disruption of cutting edge in middle third of

the instrument (20 / 0.6) (Figure 5). Debris (confirmed by EDS analysis) was observed on all instruments, both in the apical and middle third (100%).

**Figure 5.** SE image of new Mtwo instrument (20/0.6): a) area of middle third with a disruption of cutting edge defect ( $\times 350$ ); b) detail from the previous image at higher magnification ( $\times 800$ )

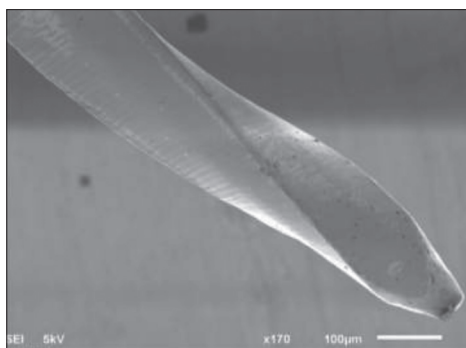
**Figure 7.** SE image of apical third of new ProTaper instrument (Sx) with corrosion and discontinuity of cutting edge (apart from the presence of pitting and fretting) ( $\times 170$ )

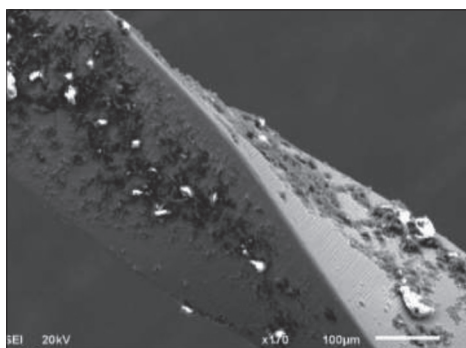
The results of SEM analysis of BioRaCe sets show the most frequent occurrence of metal strips (apical 50% and middle third

**Figure 9.** SE image of the surface of new BioRaCe instrument (No. 3) i.e. its middle third with the presence of metal strips and fretting ( $\times 170$ )

38.8%) and fretting (apical 33.3% and middle third 27.7%) (Table 4, Figure 9). Debris contamination detected by EDS analysis was observed on the apical (11.1%) and middle surface (22.2%) of the instruments.

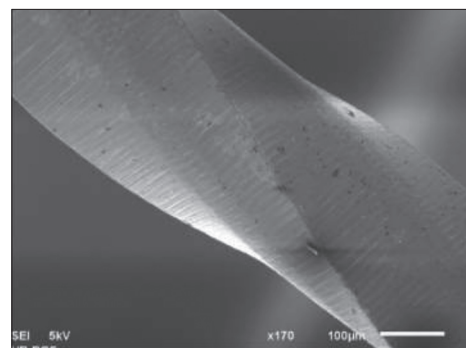
The most common defects on the working surface of new ProTaper Universal instruments were changes in the form of fretting (apical and middle third, 100%) and pitting (apical third 83.3% and middle third 88.8%) (Table 4, Figure 6). Metal strips were detected on the apical (50%) and middle third (38.8%). A defect on the cutting edge (disruption of its continuity) was observed on one, the most conical instrument (Sx) (apical and middle third), and corrosion on the apical (11.1%) and middle part (11.1%) (Figure 7). Contamination in the form of debris was noticed in apical third (100%) and in middle third of slightly more than a half (55.5%) of ProTaper Universal sets. The most common defects on new HyFlex instruments were the appearance of fretting in the form of debris on apical and middle segments of all instruments (100%) (Figure 8). A defect in the form of a microfracture was observed on the apical part of the instrument (25-0.08) as well as the appearance of metal strips (25-0.04).

**Figure 6.** SE image of middle part of ProTaper Universal instrument (F2) with pitting and fretting ( $\times 170$ )

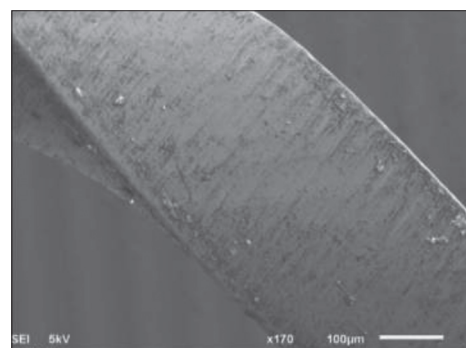
**Figure 8.** SE image of the middle third surface new HyFlex instrument (30-0.04) with the presence of fretting and debris ( $\times 170$ )
